ERDC/EL TR-04-10

*Dredging Operations Technical Support Program
Monitoring Completed Navigation Projects Program*

Guidance and Lessons Learned from Monitoring Completed Navigation Projects

June 2004

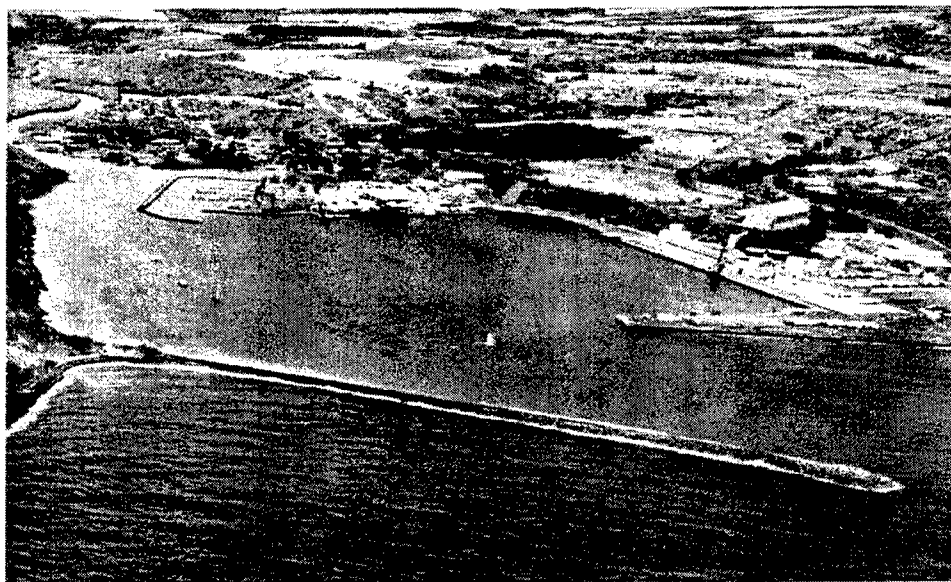
Figure 1. Nawiliwili Harbor, Kauai, HI (after Bottin and Meyers 2002a)

- b.* A total of 70 broken/cracked concrete armor units were identified in the 1995 survey, and 77 broken/cracked units were identified in 2001. However, high-wave action during the 1995 waking inspection prevented a close examination of armor units at the water's edge. Of the seven additional broken units in 2001, six were located along the water's edge and may have been broken in 1995 as the result of the excessive wave action. Therefore, it appears that minimal armor unit breakage occurred between 1995 and 2001.

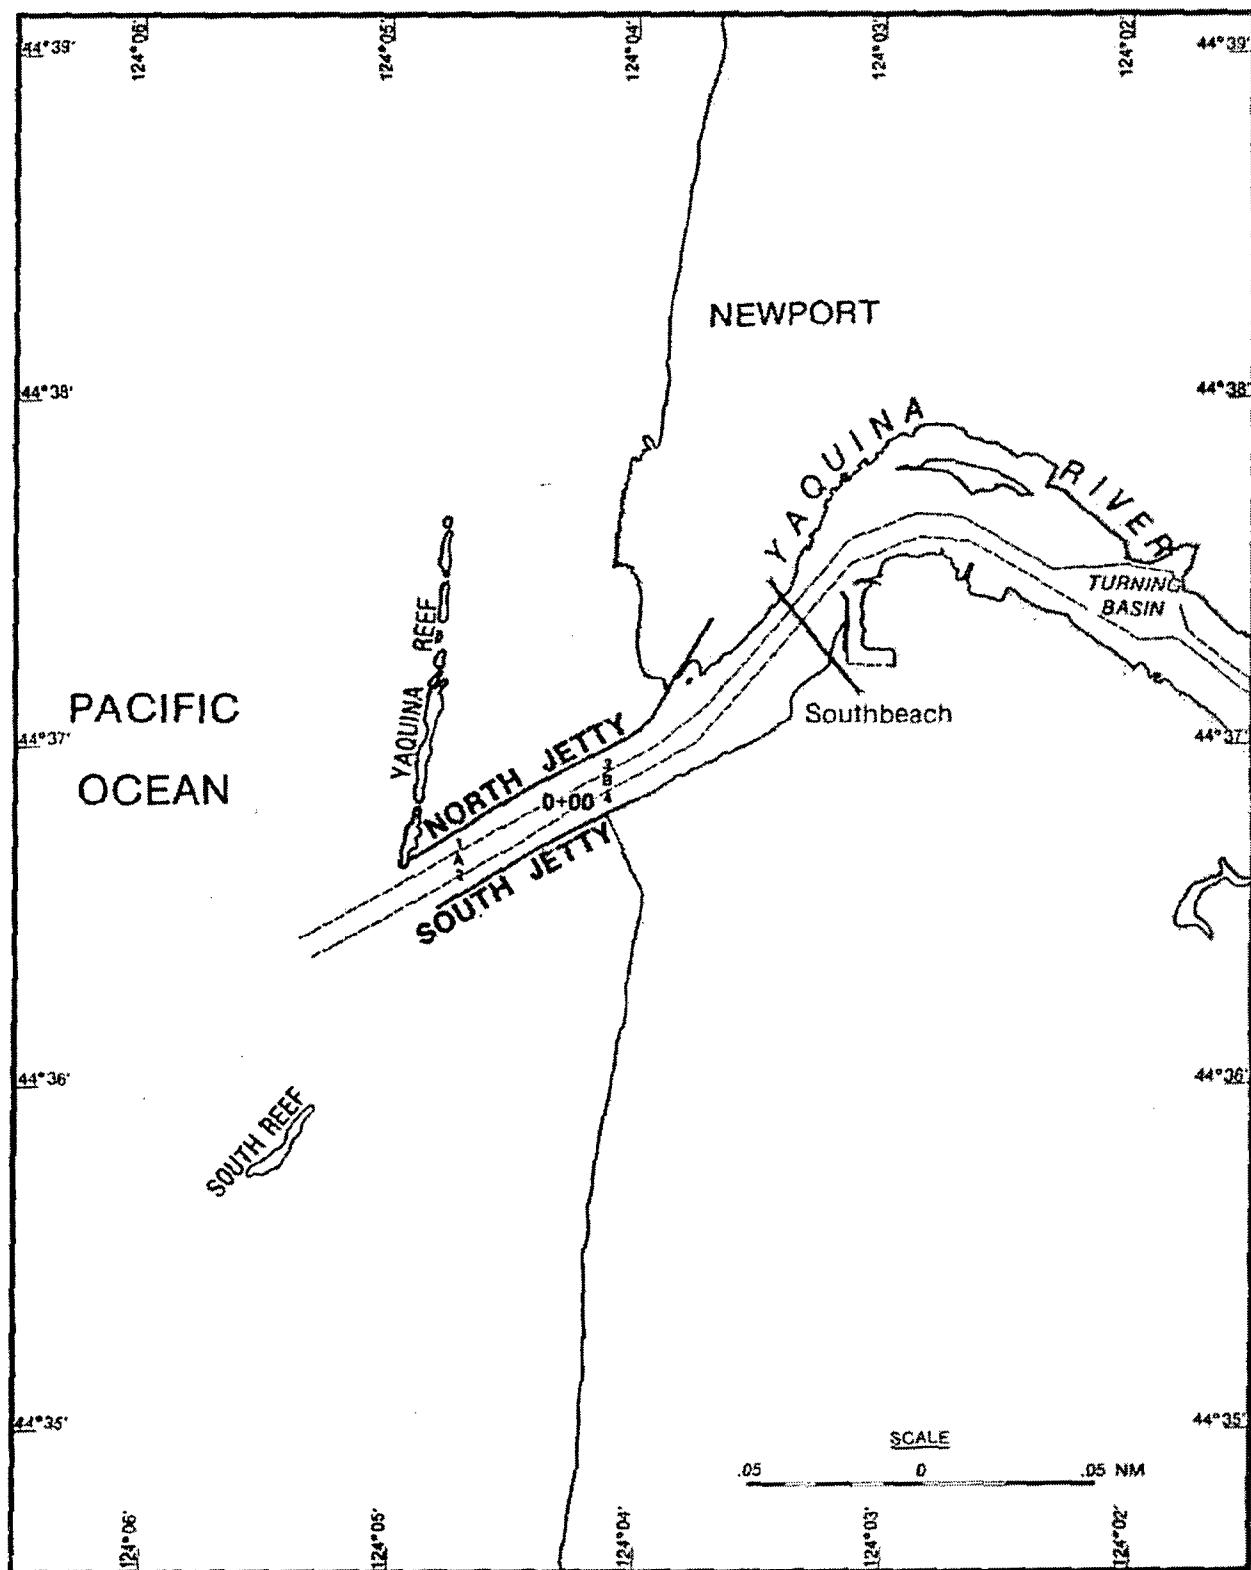
Monitoring was conducted during the time period October 1988 – September 1994 to determine the likely cause for chronic damage to the Yaquina Bay north jetty. This monitoring also offered the potential for increasing understanding of failure mechanisms associated with rubble-mound structures and for improving methods of monitoring coastal structure performance in similar hostile wave and current environments (Hughes et al. 1995).

Figure 15. Yaquina Bay, Newport, OR (after Hughes et al. 1995)
